Chapter 12

Field Fire Assessment of Homesteads and Manhattan Project and Cold War Resources Impacted by the Cerro Grande Fire

Kari M. Schmidt, Jennifer E. Nisengard, Brian C. Harmon, Alan L. Madsen, and W. Bruce Masse

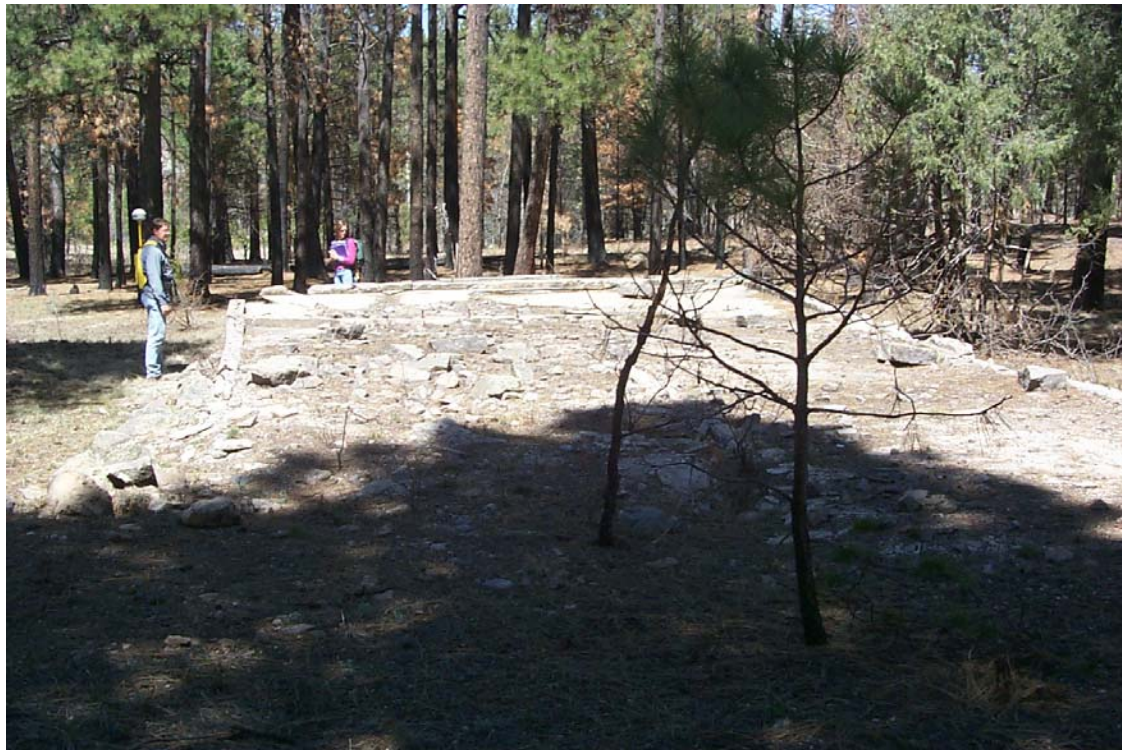
Figure 12.1. General view looking northwest of a historic foundation at LA 21369B with B. Harmon (left) and J. Nisengard.

seven structures, tuff blocks, and concrete. These features represent the remains of a pre-World War II Civilian Conservation Corps (CCC) construction camp associated with the building of State Route 4. Together these components measure approximately 100 m north-south by 20 m east-west. The site has been extensively bulldozed and is disturbed by two roads running north-south and parallel to one another. This site is fairly disturbed, a great deal of gravel litters the site and there are several large holes between the small mounds; the mounds consist of concrete and tuff blocks. Some bent metal is also present. A small concrete structure is associated with a can scatter to the north of the concentration of the structure mounds. The site burn severity is moderate. Stump and root holes exist adjacent to masonry and in the site, and additional snags are in the site area. No treatment is recommended for this site.

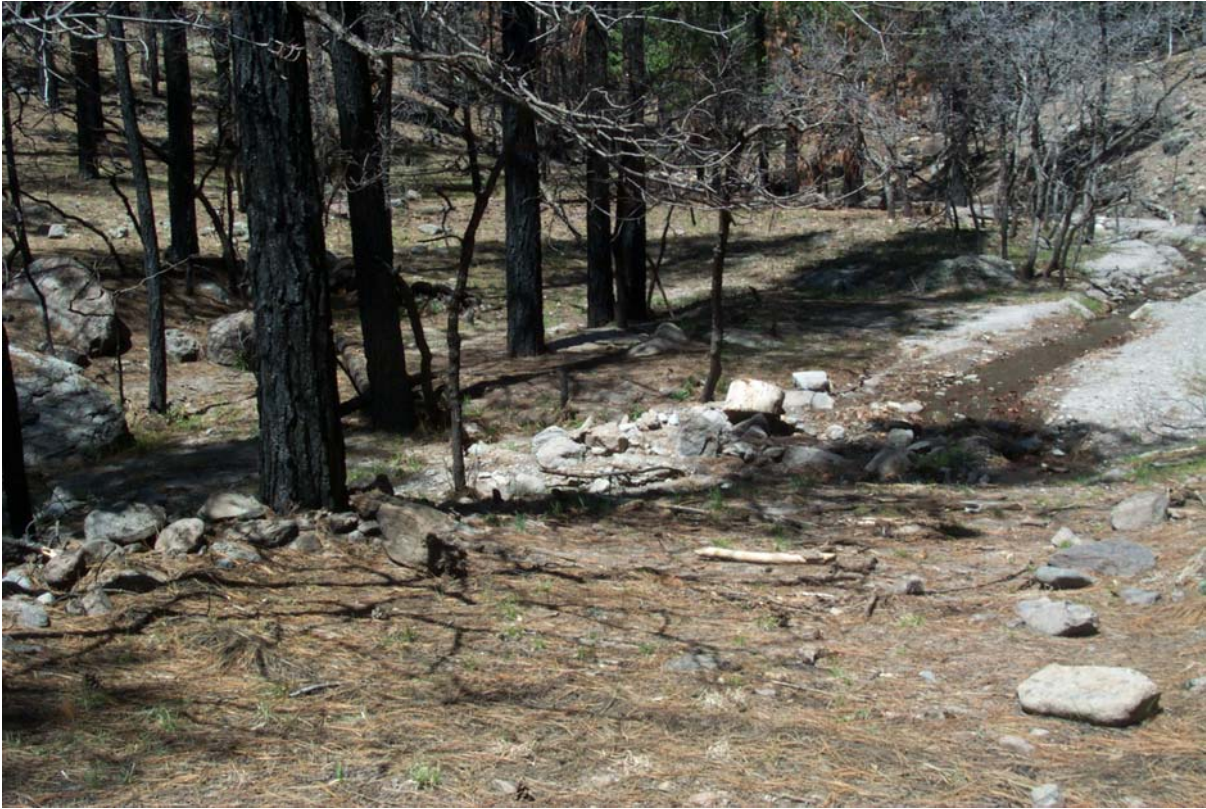
LA 89826. Before the Cerro Grande revisit, the site was most recently surveyed in 1993. In both visits, the site was identified as a Homestead period structure. The site consists of the collapsed portions of a wooden bridge over a segment of LA 89825 (Figure 12.2), a Homestead period wagon road. Nothing remains of the wooden structure as it appears to have washed away. There is a single piece of burned wood lodged between two rocks on the south side of the crossing. It is probable that this is the only piece of wood remaining. No artifacts were identified during either visit. LA 89826 was located in a mixed ponderosa pine forest and piñon-juniper woodland. The area around the site was minimally burned during the Cerro Grande Fire. In addition to the destruction of the wooden bridge, the fire also affected the site in the form of 10 partially burned trees in the immediate site vicinity. The site was not impacted by suppression or rehabilitation activities. Dendrochronological dating of bridge specimens proved unsuccessful, however one element could be matched with the Anchor Ranch Ice House (see Appendix I).

Figure 12.2. LA 89826, a Homestead period structure after the Cerro Grande Fire.

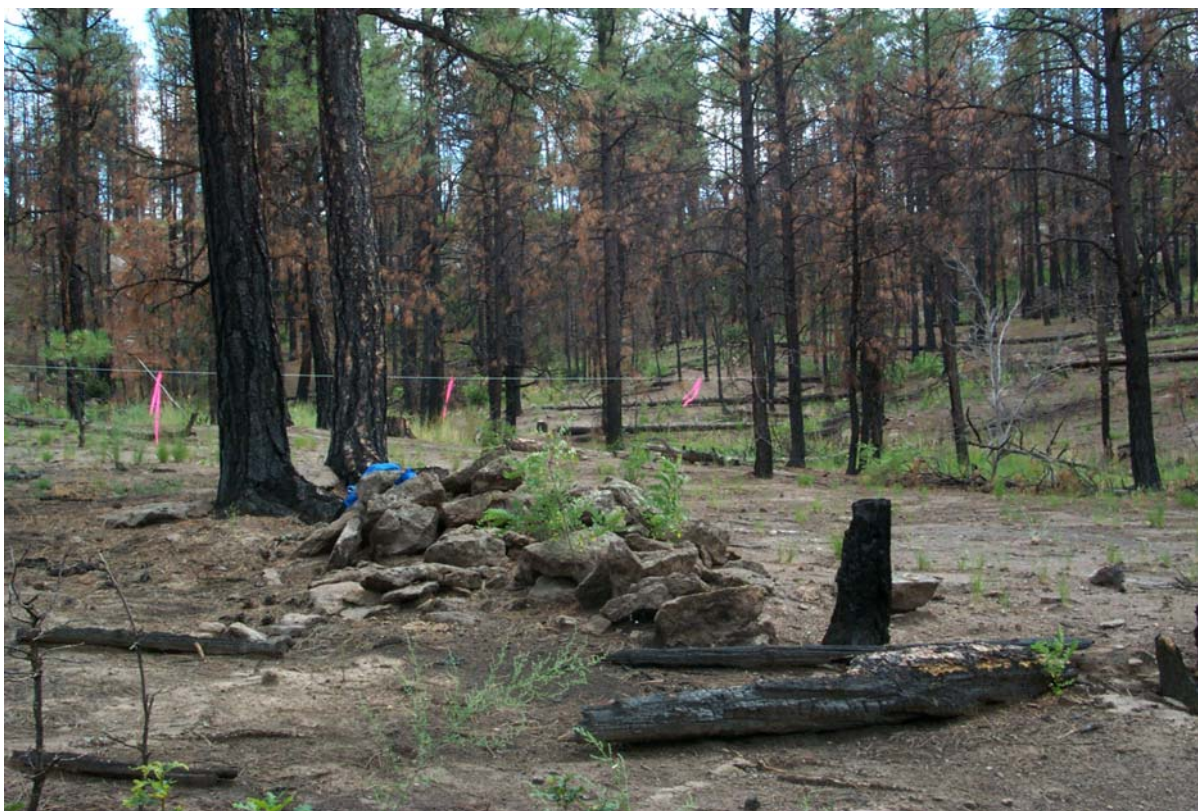
Figure 12.3. LA 21298, a Historic period structure after the Cerro Grande Fire.

ponderosa pine forest and piñon-juniper woodland, with a fairly high density of scrub oak in the area. The area around the site was severely burned as is evidenced by cracking, spalling, and soot damage on the masonry blocks; stump and root holes on the site itself as well as in the surrounding area; snags and partially burned trees in both the immediate and general vicinity of the site; and the loss of architectural wood in the form of a ramada. The site was not impacted by suppression or rehabilitation activities, but because of the extensive damage, it is suggested that potentially threatening trees in the area be removed.

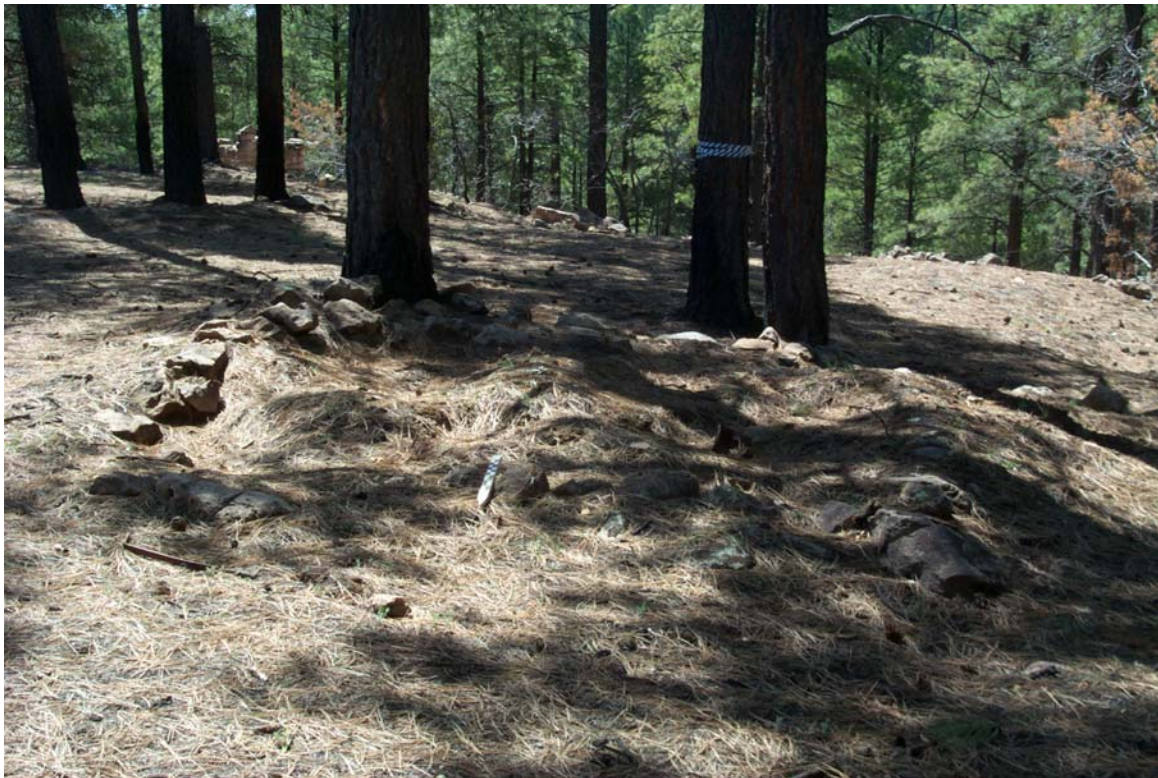
Figure 12.4. LA 86643, the cabin foundation after the Cerro Grande Fire.

Several of the cabin foundation blocks have been discolored by smoke damage. The corral area is burned with trees being burned at the base. The northwest section of the masonry wall of the corral is most heavily burned. Remnants of a burned post are present in the north-central sections of the corral, and

| Technical Area | LA Number | Site Type | Type of Action to be taken at Site | Recommended Treatment |
|---|---|---|---|---|
| 22 | 86643 | Historic structure | Treatment | Cut down trees in feature corral |

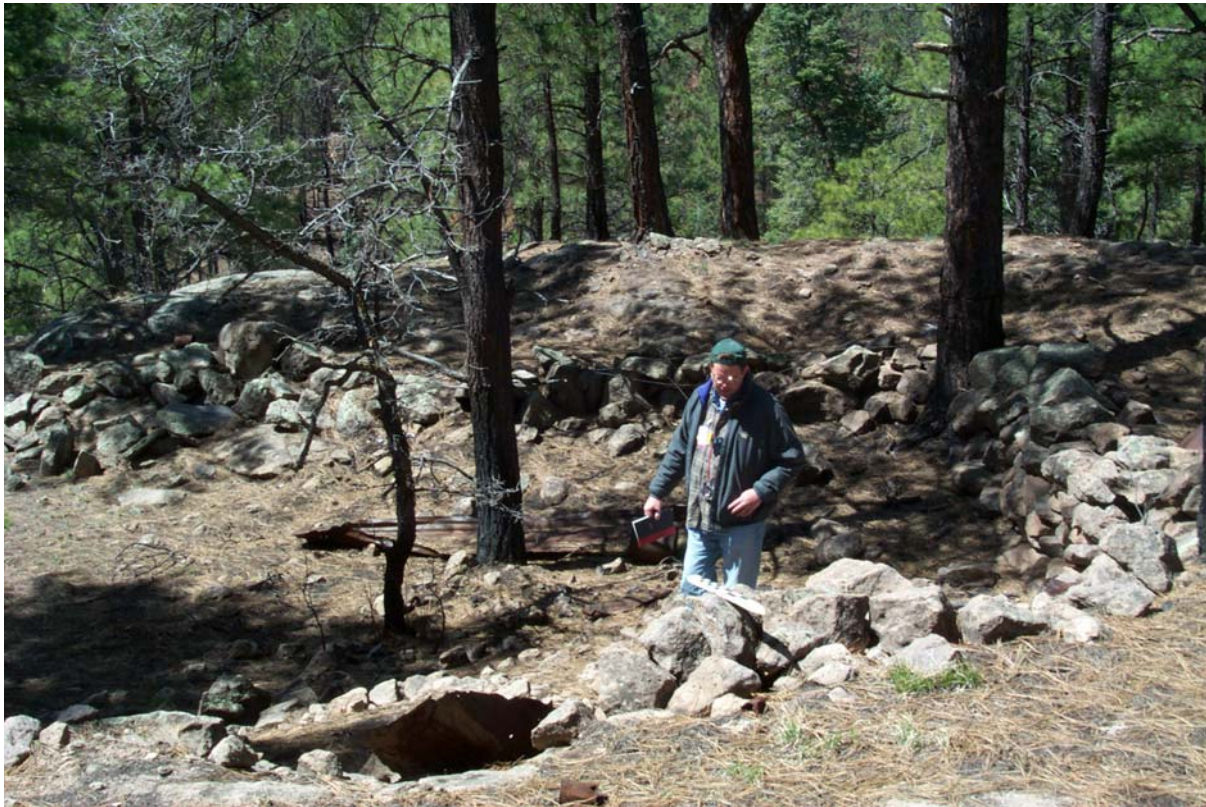
about 10 pieces of corrugated metal are also burned. The trash dump area was heavily burned, and while the artifacts suffered damage, they are all still intact. The area around the fence line was also burned, but there are still about 30 wooden fence posts present, five of which are still upright. The stone structure and the horno were not burned during the fire. In addition to these effects, evidence of the burn is also present in the form of approximately 20 partially burned trees in the site area that have the potential to further damage the structures. Architectural wood was also lost. Because of the heavy damage the site sustained, especially the corral, it is recommended that the burned trees in the corral be cut down to prevent further damage. The site was not impacted by suppression or rehabilitation activities. An attempt was made to dendrochronologically date the Gomez homestead fenceline, however this proved unsuccessful due to the erratic nature of the ring series of the juniper posts (see Appendix I).

Figure 12.5. LA 86643, B. Harmon at the corral after the Cerro Grande Fire.

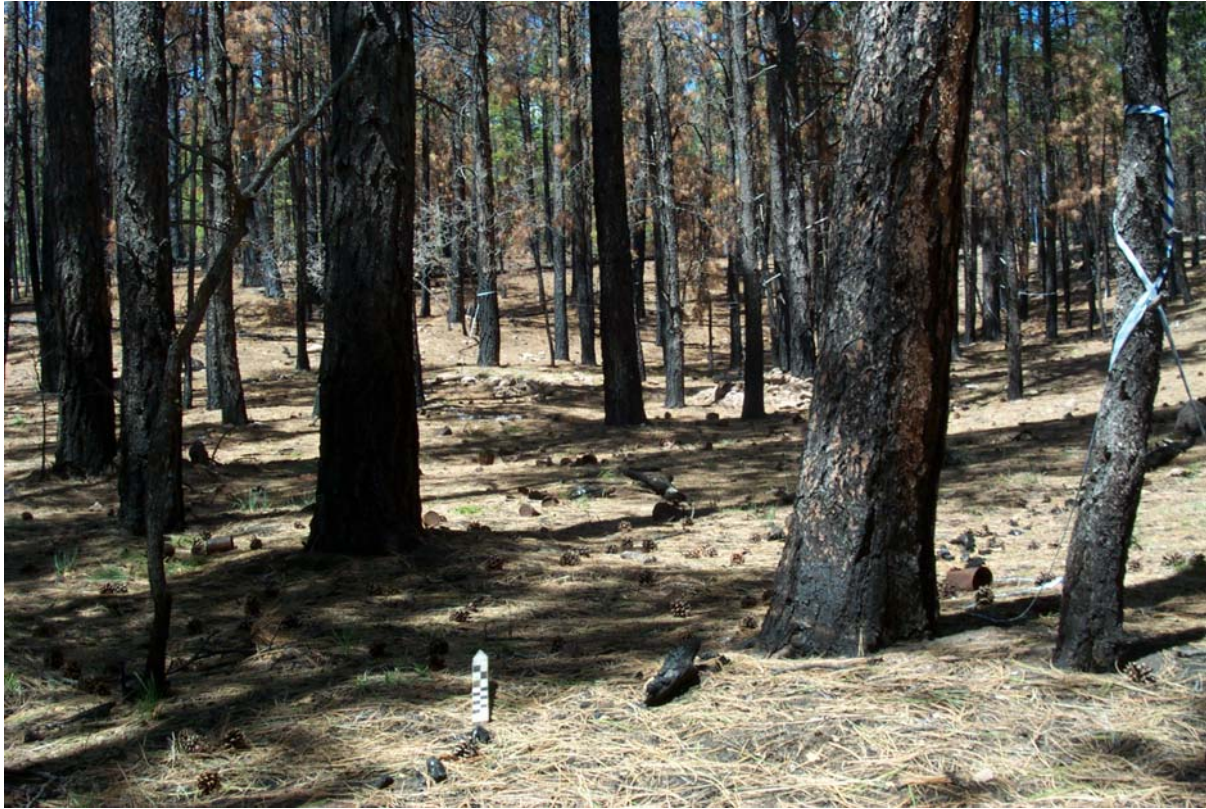
LA 89769. Before the Cerro Grande revisit, the site was most recently surveyed in 1992. In both visits, the site was identified as a Homestead period artifact scatter (Figure 12.6). Items at the site include approximately 120 metal cans, three glass shards, and three broken bottles. The cans were burned during the fire but remain intact. Heavy pine duff obscures the ground surface, and more trash could be present below the duff level. LA 89769 is located in a mixed ponderosa pine and piñon-juniper area. The area around the site was severely burned during the fire. The effects are evidenced by approximately five stump holes in the site area and over 30 partially burned trees. Because of the severe burn, most of the duff is gone. As a result, it is recommended that two wattles be placed upslope and downslope (one each) of the trash scatter. The site was not impacted by suppression or rehabilitation activities.

Figure 12.6. LA 89769, an artifact scatter after the Cerro Grande Fire.

| Technical Area | LA Number | Site Type | Type of Action to be taken at Site | Recommended Treatment |
|---|---|---|---|---|
| 22 | 89769 | Artifact scatter | Treatment | Place one wattle upslope of trash scatter and one downslope of scatter |

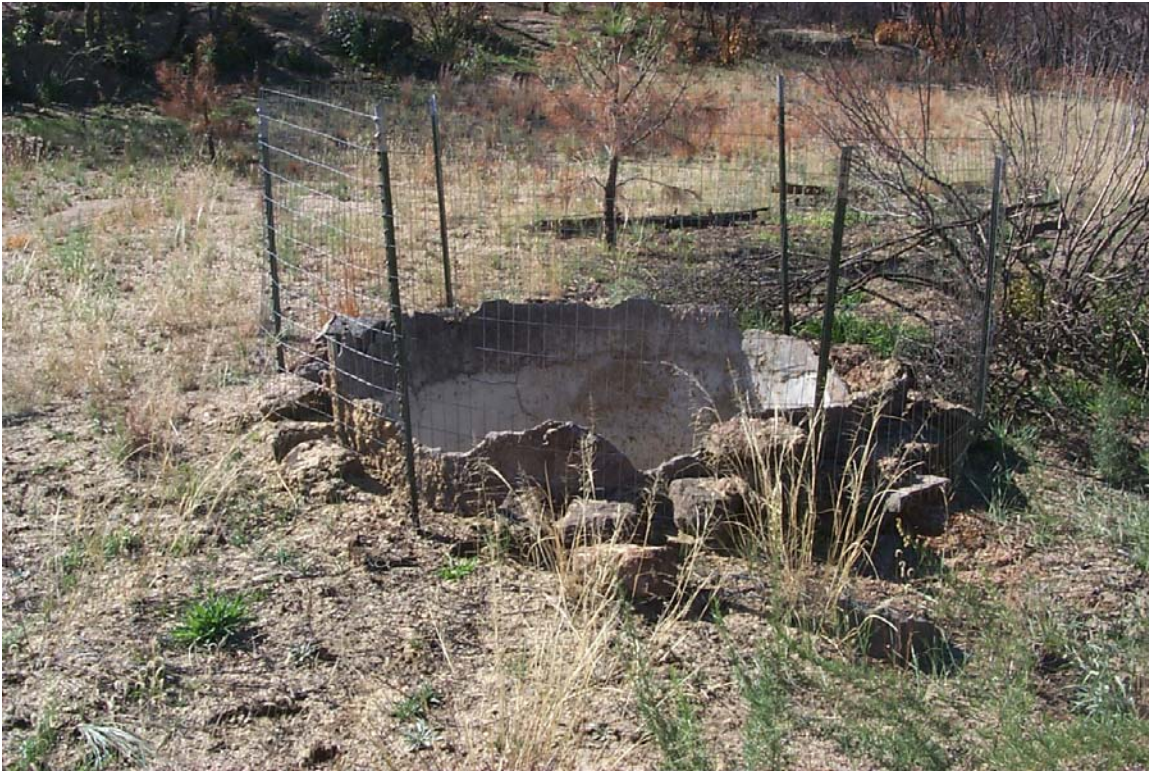
LA 30638. Before the Cerro Grande revisit, the site was most recently surveyed in 1998. During this inspection, the site was identified as part of the Fermin Vigil homestead, with a cement-lined cistern (Figure 12.7) and historic trash scatter present. During the Cerro Grande revisit, the site was identified as a historic cistern and associated trash scatter dating to the Homestead period. The site is located in the bottom of Mortandad Canyon and was severely impacted by the fire. The severity of the burn is evidenced by the destruction of wooden structures (fence posts) associated with the site, as well as by cracking, spalling, and soot damage on the cistern itself and the presence of numerous partially burned trees in the site area. The snags pose a potential threat to the cistern, especially if they fall and further damage the masonry structure. In addition to impacts from the fire itself, the site has also been impacted by several rehabilitation activities, including the felling of a single tree, the placement of mulch across the site, and a fence around the cistern. The site was not impacted by suppression activities.

Figure 12.7. LA 30638, a cistern with associated masonry.

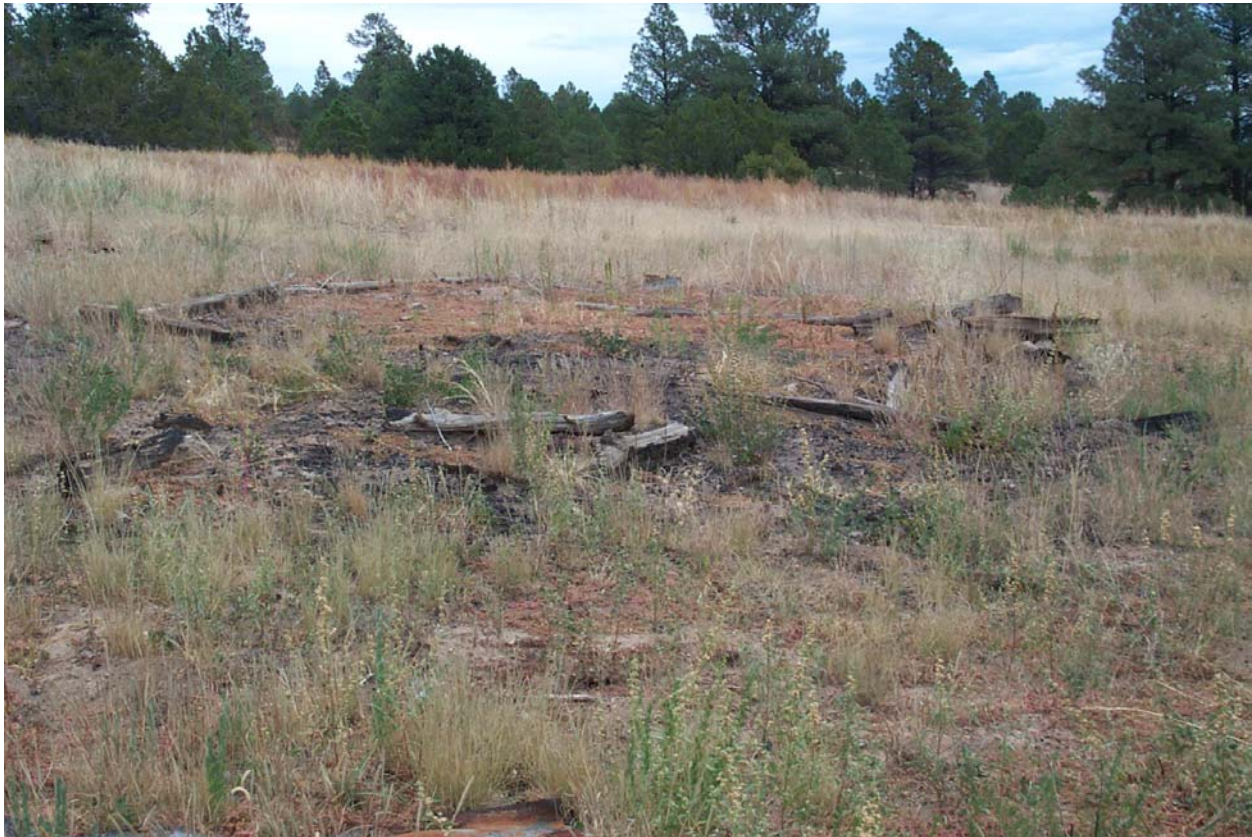
LA 85407. This site (Figure 12.8) was last visited in 1992 as part of the Bason Land Exchange. The site is part of the historic Serna homestead consisting of the remains of a log cabin, a second possible log structure of unknown use, a corral, a fence line, a trash scatter, and two rock features (possible hornos). While the site itself measures 100 m by 90 m, the entire homestead tract covered a little over 60 ac. Artifacts in the trash scatter and on other parts of the site include lard, sardine, coffee, kerosene, and condensed milk cans, galvanized metal, and purple glass fragments. The homestead was inhabited by the family of Fidel Serna, and later the family of José María Serna, from the early 1900s to 1942 or 1943 (Peterson and Nightengale 1993:50–57). There is also a very light scatter of prehistoric artifacts on the site consisting of several obsidian flakes, one Biscuit B sherd, and two Kapo Black sherds. The site is located on a small bench to the north of the canyon. Vegetation consists mostly of short grasses and small stands of piñon and juniper. The area in general is moderately burned, although most of the wood from the cabin, the possible structure, and corral was destroyed. The fence posts also suffered some damage although many of them are still present. Attempted dendrochronological dating of four log specimens from the site proved unsuccessful (see Appendix I).

Figure 12.8. LA 85407, view of cabin remains, facing northeast.

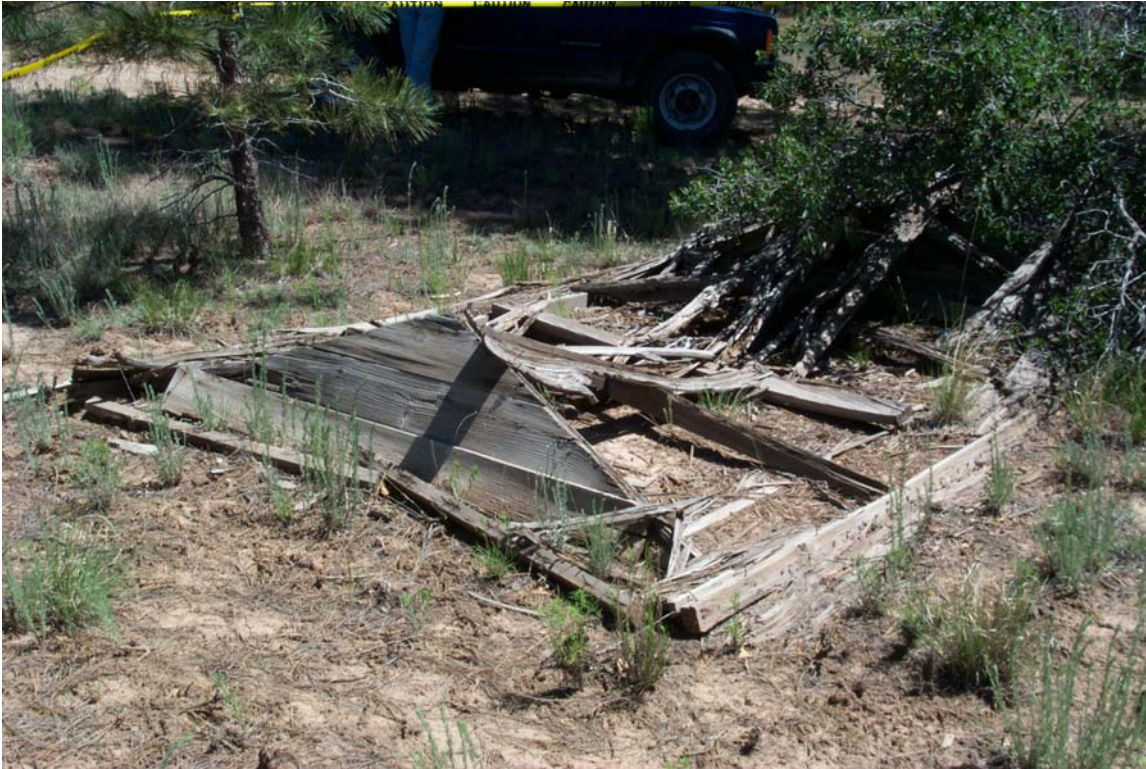
LA 131234. Before the Cerro Grande revisit, the site was most recently surveyed in March 2000 (Masse et al 2001). In this visit, as well as the Cerro Grande Fire revisit, the site was identified as consisting of three historic storage structures dating to the Manhattan Project period. These structures are identified as “bomb huts”—that is, wooden storage structures that contained casings and other such components of nuclear weapons prior to their assembly. These three storage units are referred to as Structures A, B, and C. Structures A and B were completely burned during the Cerro Grande Fire, and only small, isolated portions remain. Structure C escaped direct fire effects and appears to be mostly undisturbed (Figure 12.9). The structures are located in the ponderosa pine forest, and there is some scrub oak in the area. The area around the site was moderately burned during the fire, and a significant amount of architectural wood was lost, specifically that associated with Structures A and B (Figure 12.10). Despite significant losses from the fire itself, the site was not impacted by suppression or rehabilitation activities.

Figure 12.9. LA 131234, Structure C after the Cerro Grande Fire.

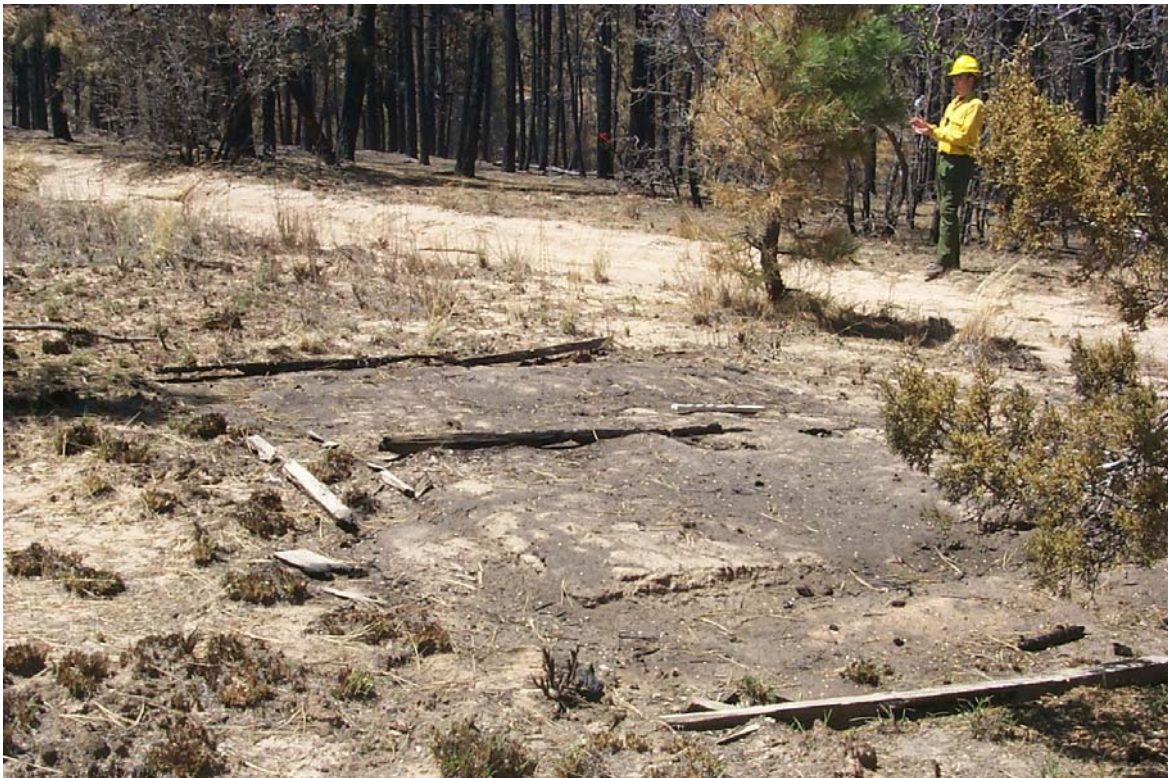
Figure 12.10. LA 131234, A. Madsen at Structure B after the Cerro Grande Fire.

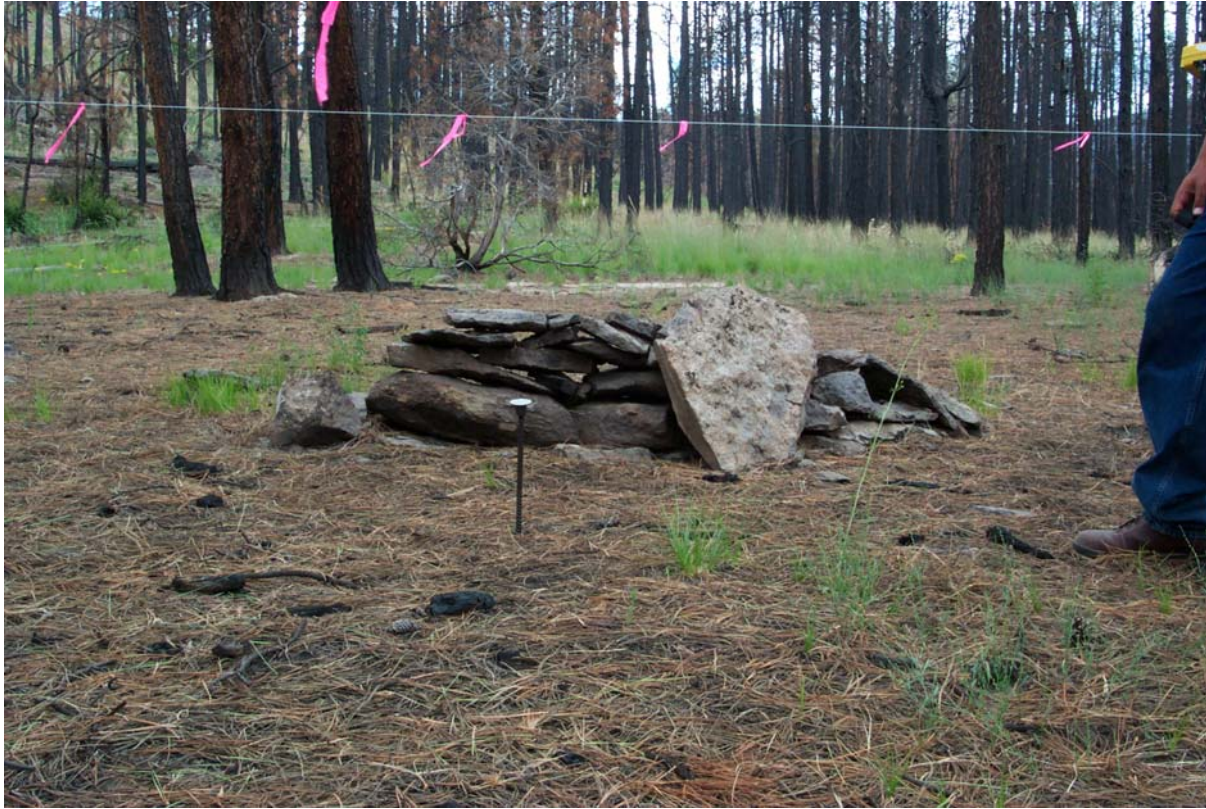
LA 89838. Before the Cerro Grande revisit, the site was most recently surveyed in 1996. In both visits, the site was identified as a Historic period rock feature consisting of a small, somewhat curved alignment of flat, tabular, rhyolitic slabs piled four courses high (Figure 12.11). The alignment appears to represent some sort of hunting blind or windbreak. Based on the presence of axe cut timbers, the site was assigned to the Historic period. The site is located in a mixed ponderosa pine and piñon-juniper woodland area. The area around LA 89838 was severely burned during the Cerro Grande Fire as is evidenced by cracking, spalling, and soot staining on a large percentage of the masonry blocks; stump and root holes both on the site itself and in the immediate area around the site; the loss of architectural wood that was referenced in the 1996 visit; and partially burned trees both on the site itself and in the general site area. Despite the severe burn, however, the site was not impacted by suppression or rehabilitation activities.

Figure 12.11. LA 89838, a Historic period rock feature after the Cerro Grande Fire.

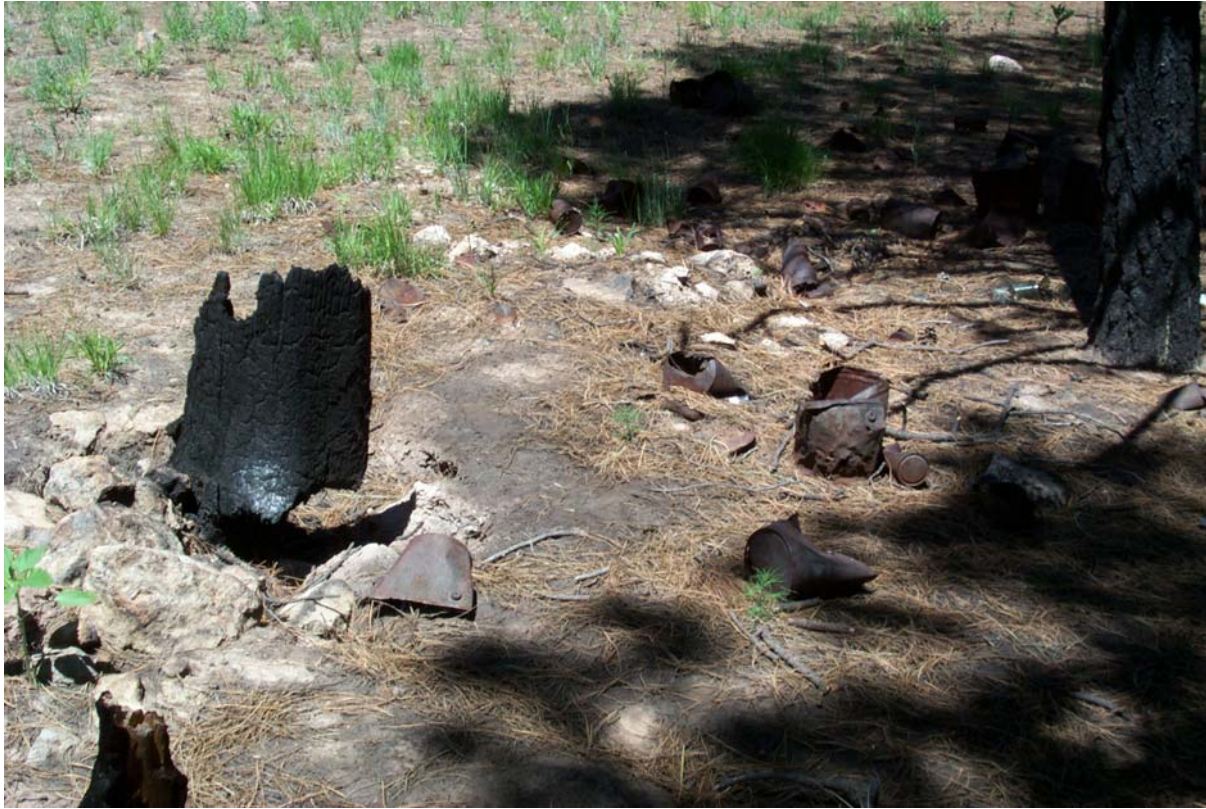
LA 131236. Before the Cerro Grande revisit, the site was most recently surveyed in March 2000. In this visit, as well as during the Cerro Grande Fire revisit, the site was identified as a Homestead period artifact scatter. Items at the site include leather and other perishable materials, as well as a wide array of historic cans. The site is located in the ponderosa pine forest and scrub oak woodland. The area around the site was moderately burned during the fire as is evidenced by stump holes, partially burned trees in the site area, and burned artifacts. Because of the effects of the fire, and primarily due to the accelerated decomposition rates in the site area, data recovery is recommended. These efforts should take the form of intensive analysis of surface artifacts and the collection of pertinent items. Despite significant losses from the fire, however, the site was not impacted by suppression or rehabilitation activities.

Figure 12.12. LA 131236, with stump holes in the artifact scatter.
